Identification of Microcracks caused by Autogenous Shrinkage

Pietro Lura,
Ye Guang, Kyoji Tanaka,
and Ole Mejlhede Jensen

Tokyo Institute of Technology, Yokohama, Japan

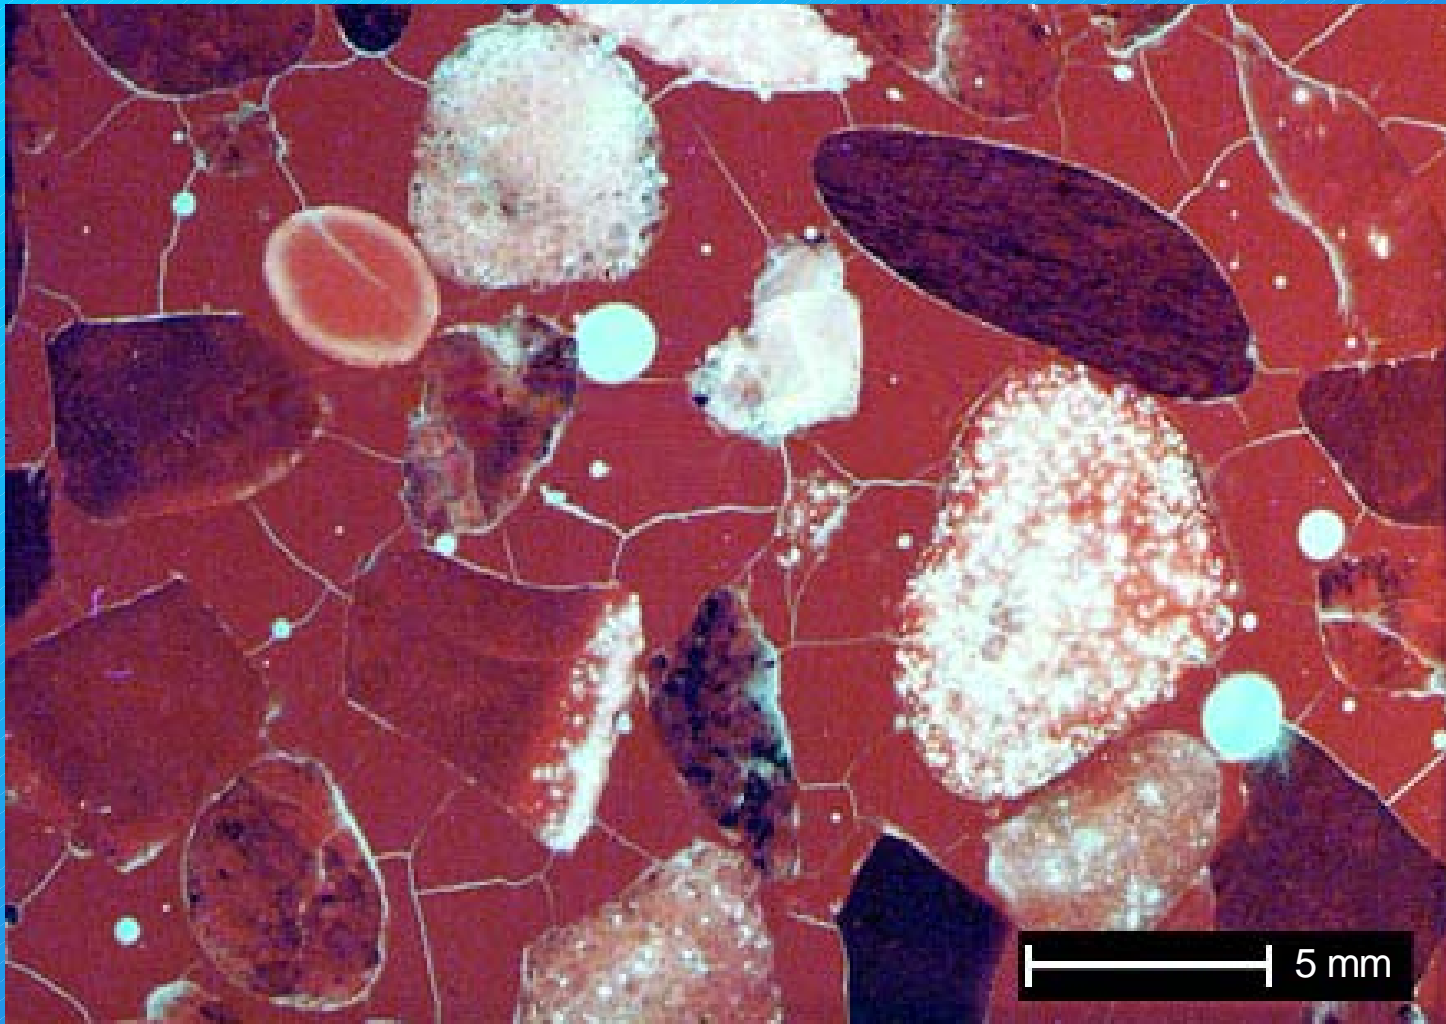
Internal microcracking

(Dela & Stang 2001)

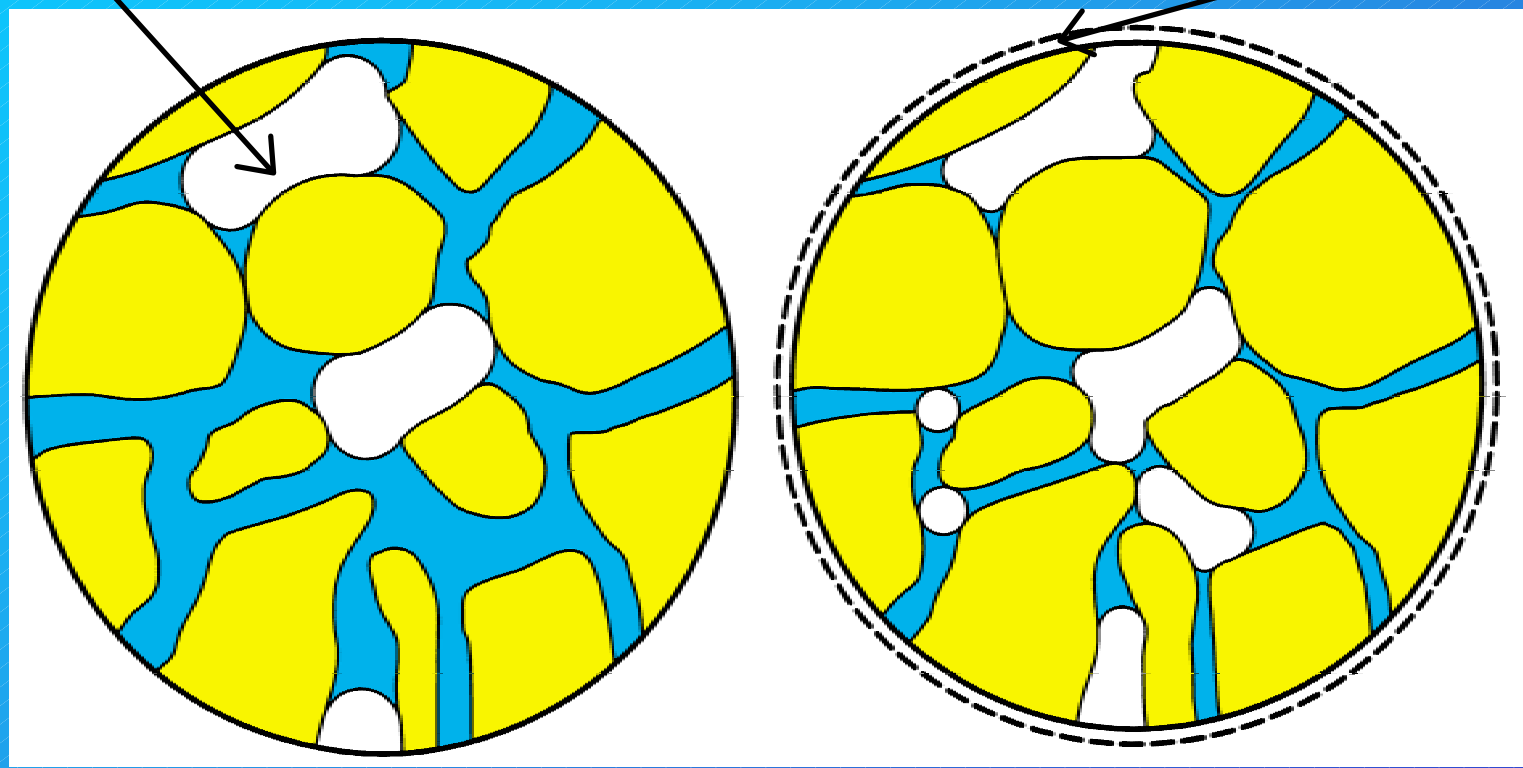
Chemical shrinkage

Autogenous shrinkage

(Jensen 1993)

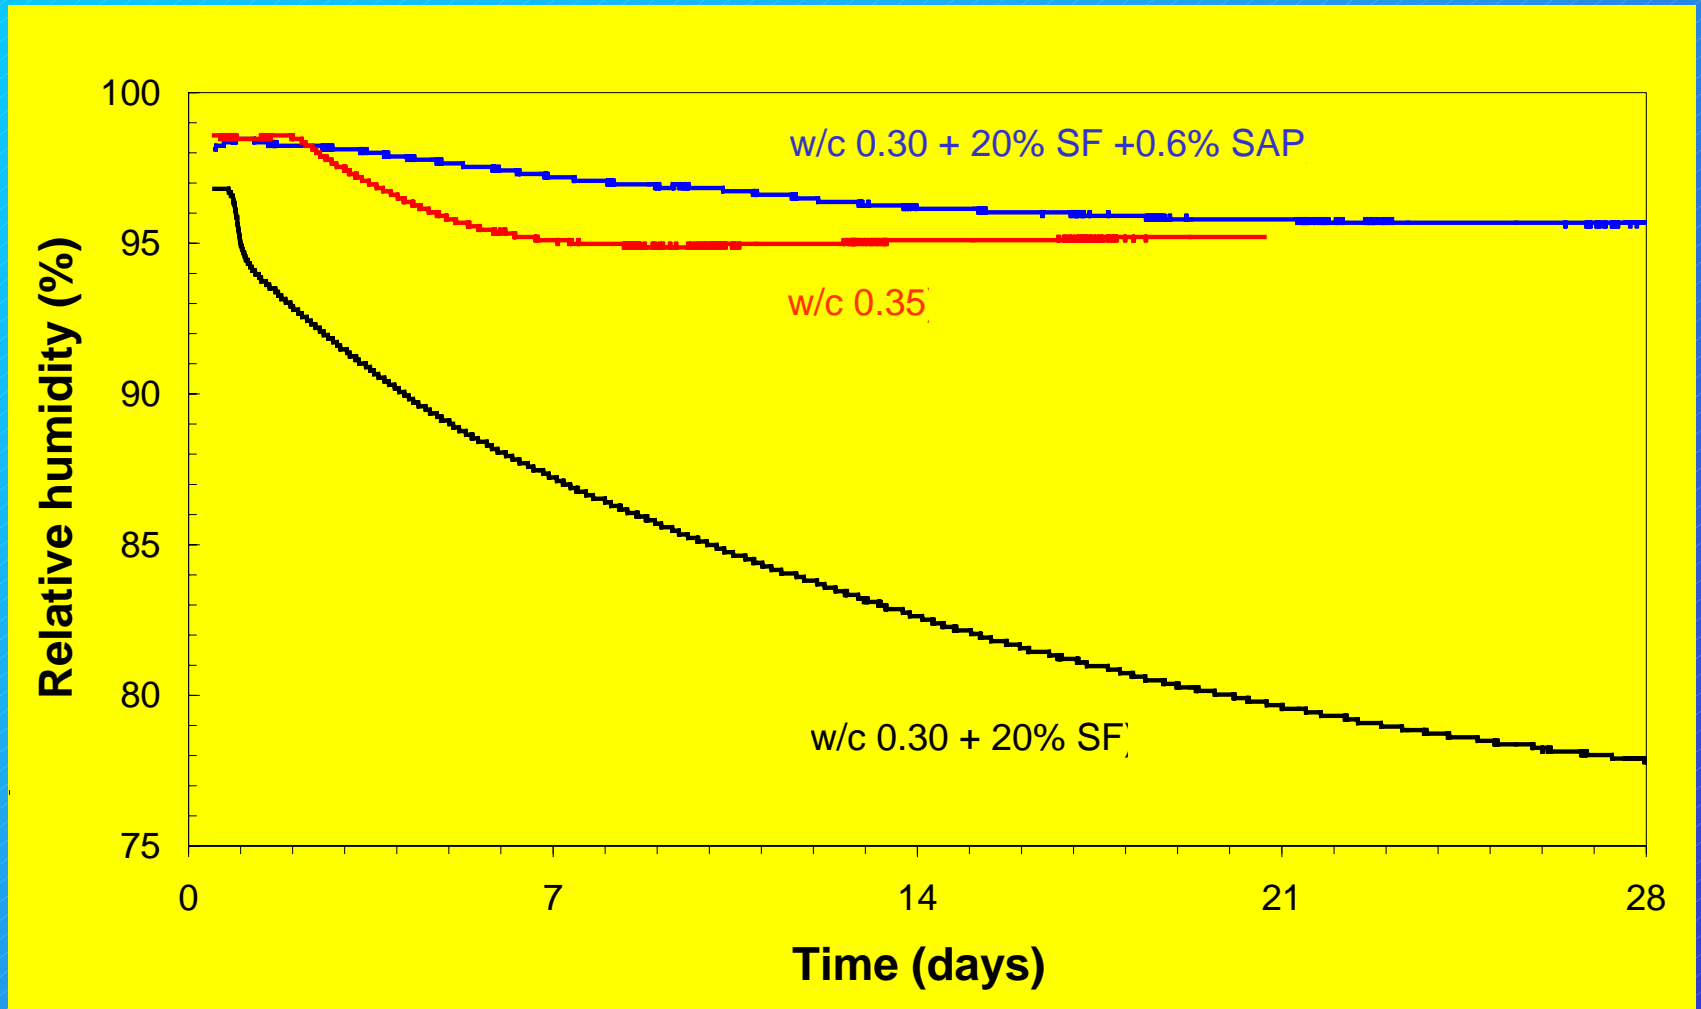
Autogenous relative humidity

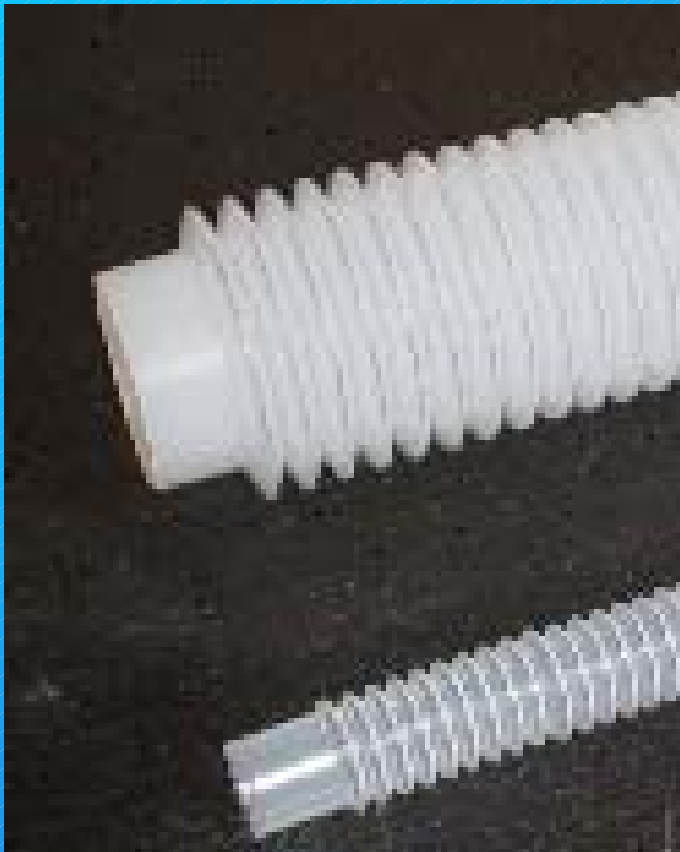
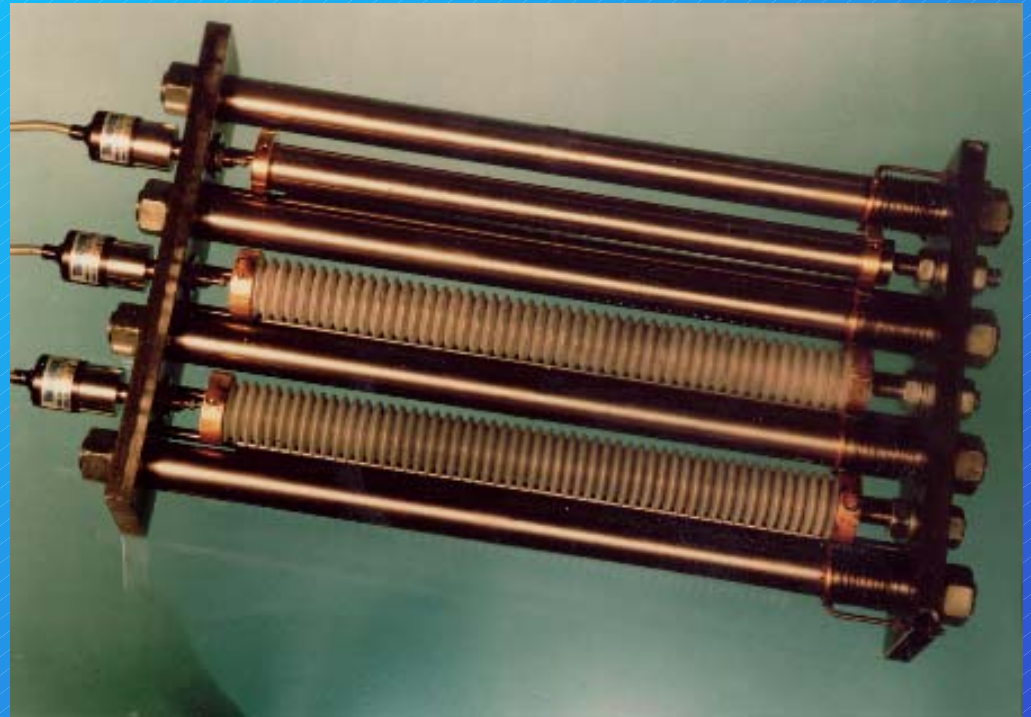
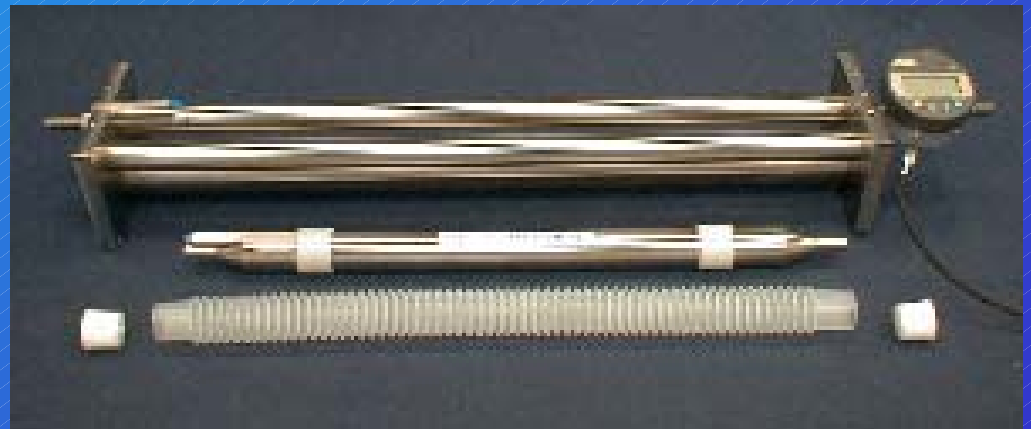
Autogenous strain - linear technique

Corrugated moulds

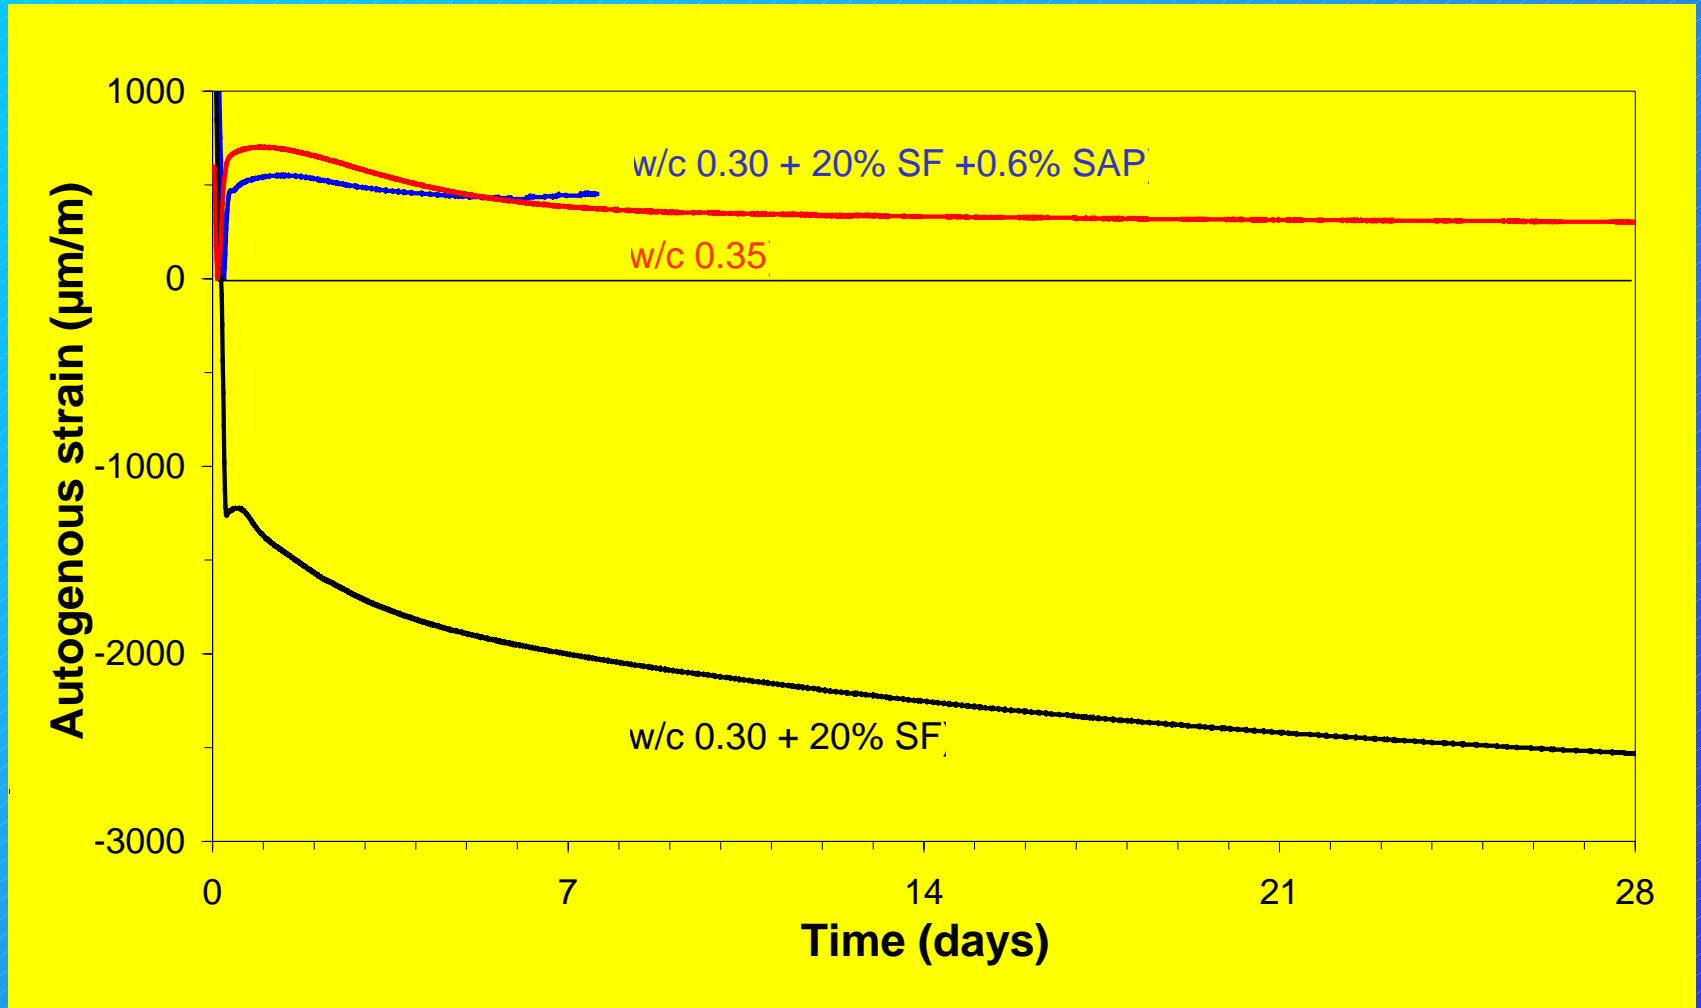
Autogenous strain

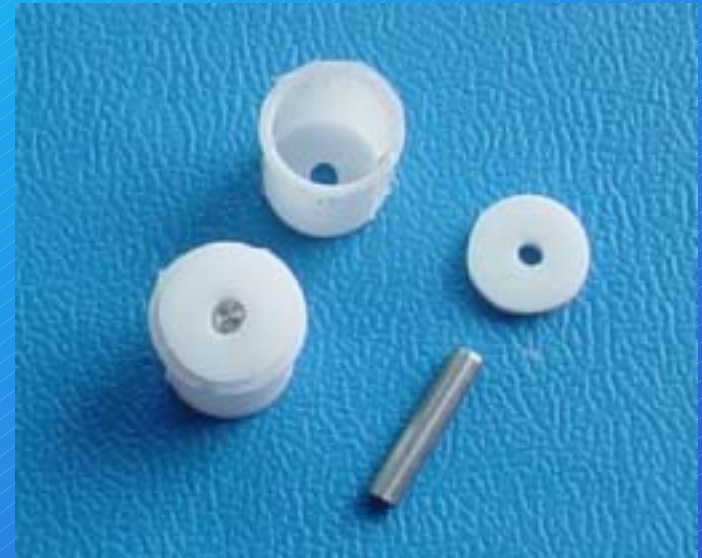
Samples for crack detection

- 3 cement pastes
- 0, 1.5, 3, and 6-mm rods
- 1 month sealed at 32°C

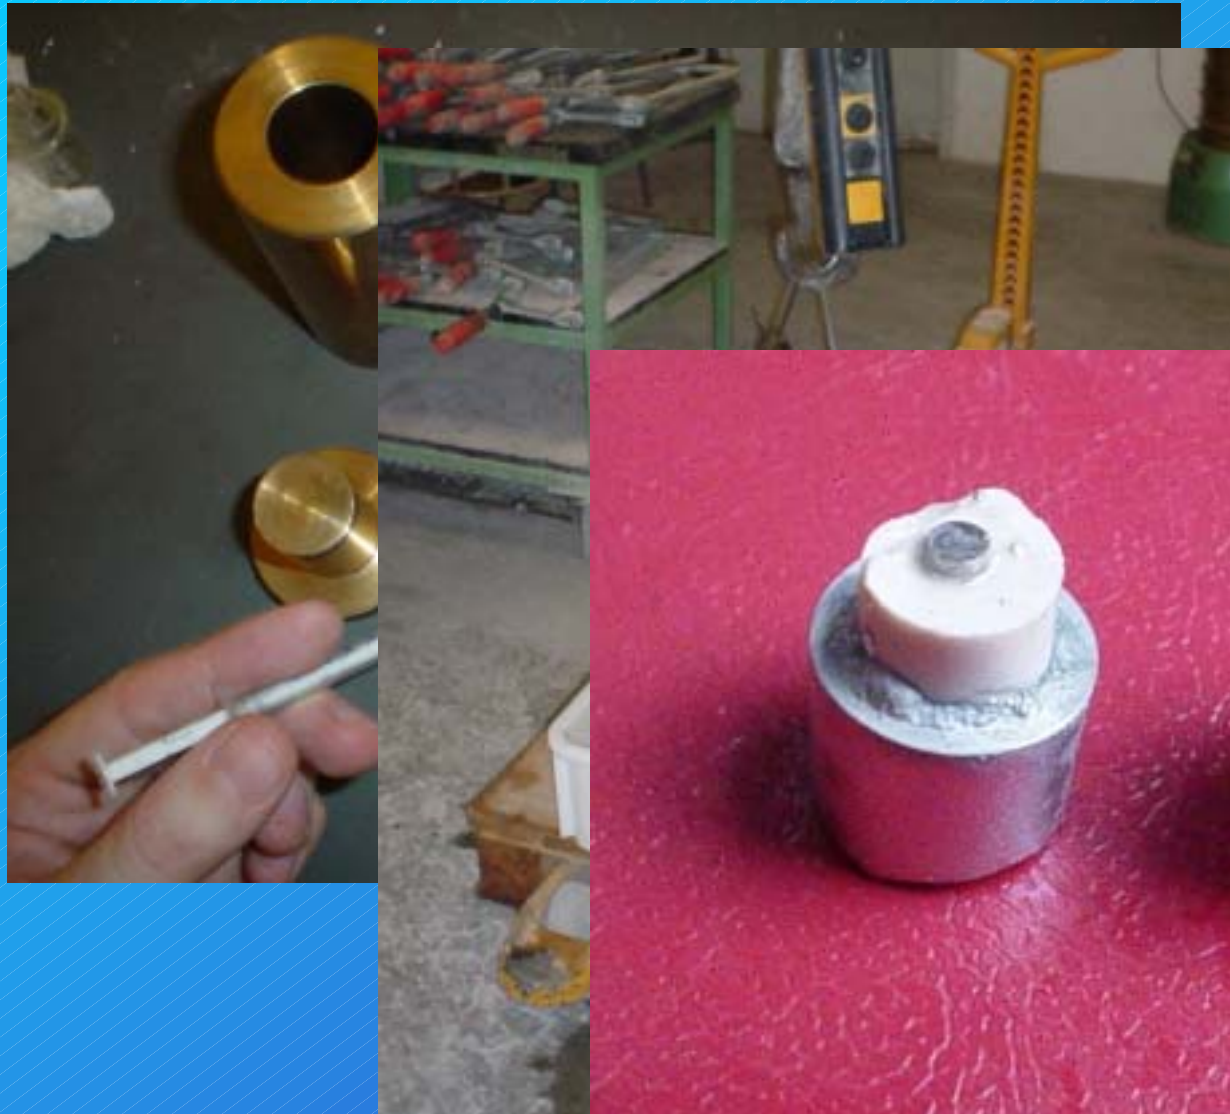
Gallium intrusion
