Recent solutions to improve the degraded ballasted tracks

Railway Technical Research Institute
Yoshitsugu Momoya

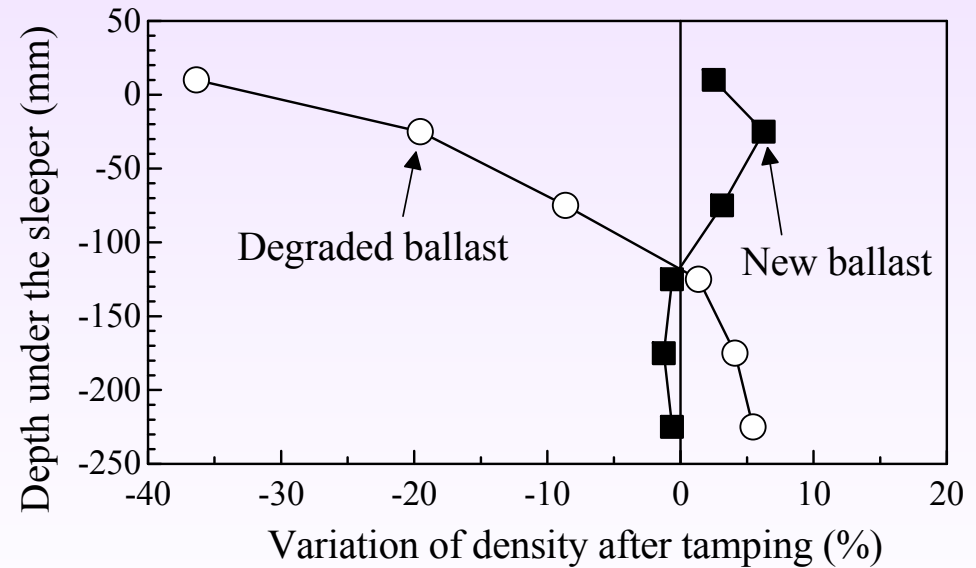
Density after the tamping

- ◆ The density of the degraded ballast does not increase by tamping.

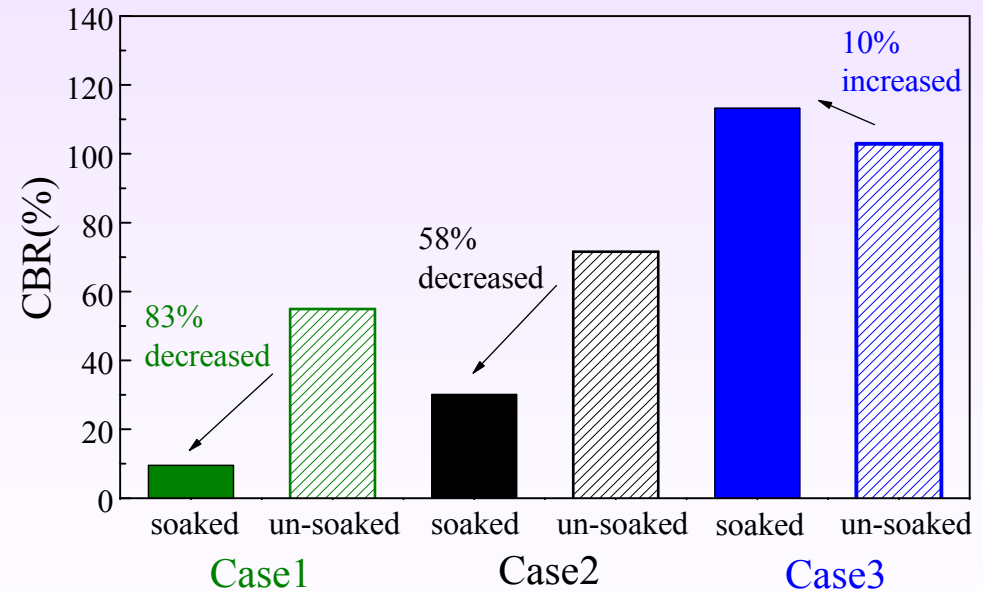
CBR test result

- ◆ CBR value of the degraded ballast significantly decreases after the soaking.

- Stability of the degraded ballast became much less under the saturated condition.
- Roadbed improvement with grout and degraded ballast effectively reduced the settlement of the sleeper.
- Polymer improvement effectively reduced the settlement of the sleeper.

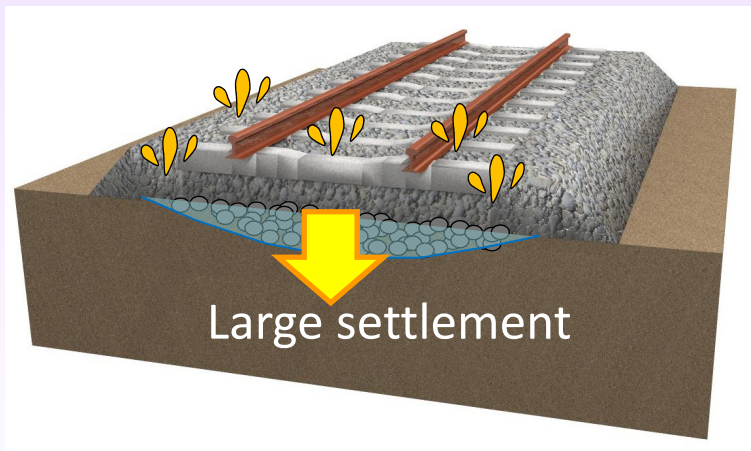
Without improvement

- ◆ Settlement of the ballasted track becomes less after roadbed improvement.

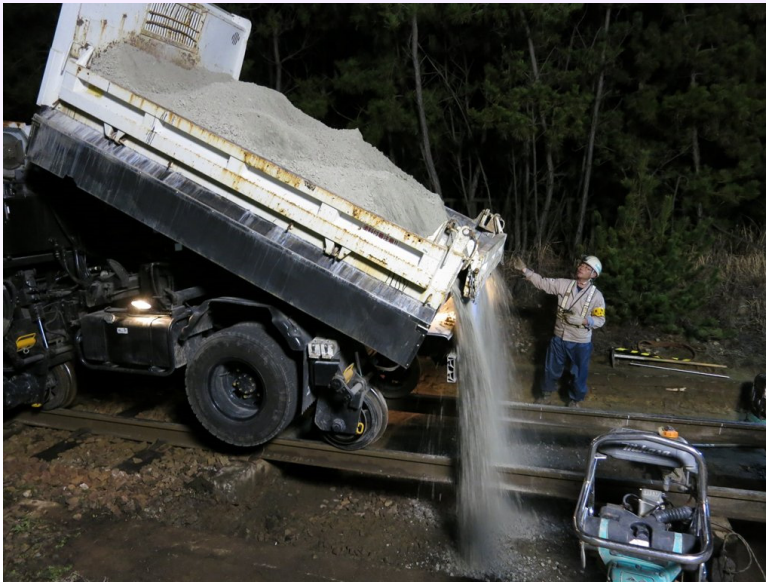
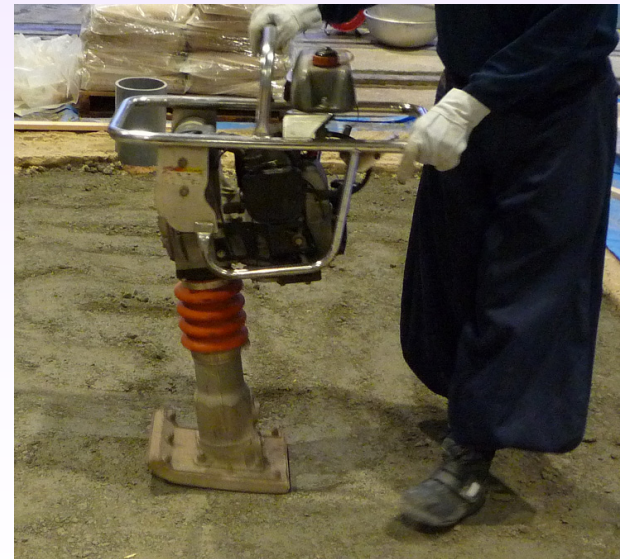
Conventional roadbed improvement method:
Crushed stone, steel slag, cement treated material.

Sufficient compaction work was necessary.

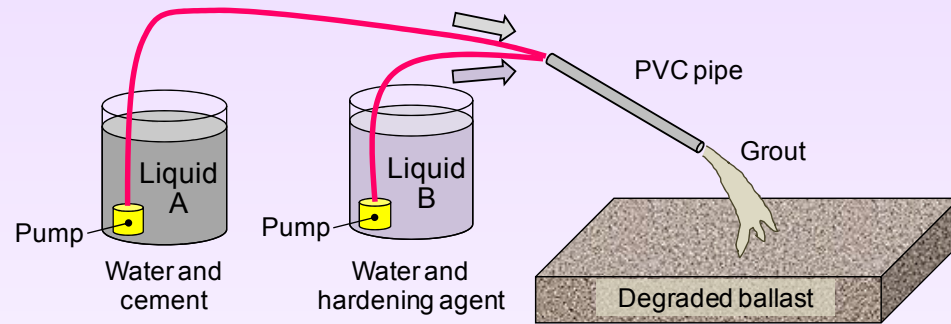
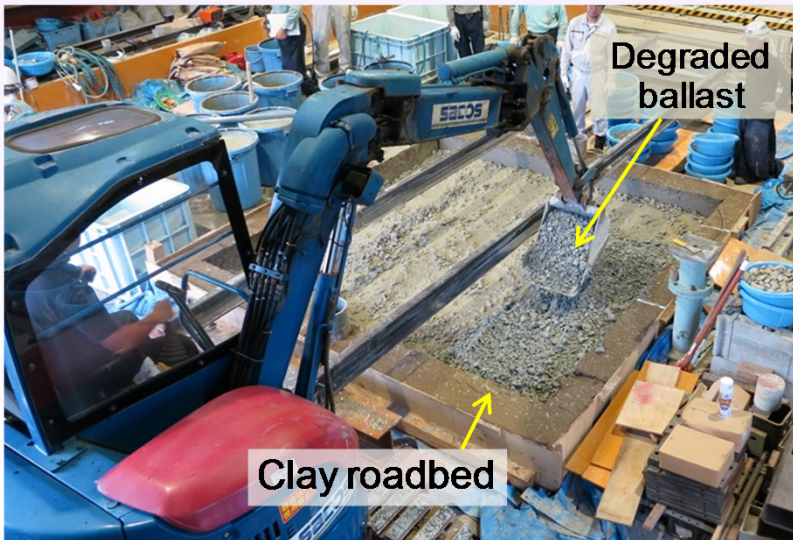
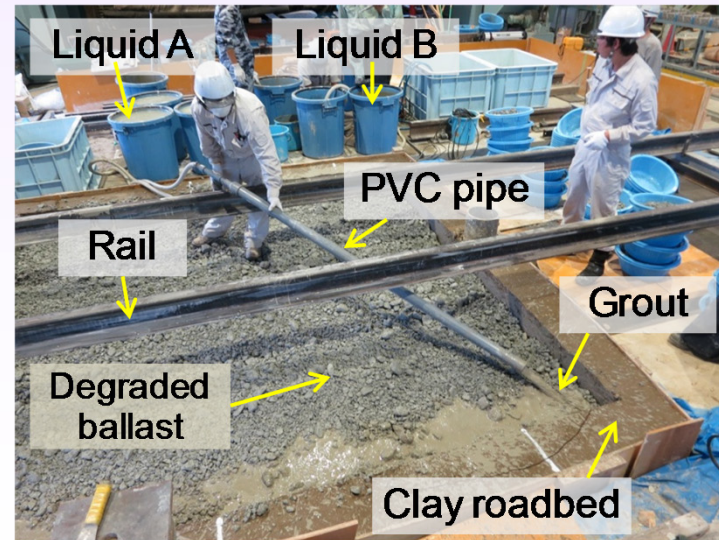
- ◆ Reusing degraded ballast mixed with cement grout.

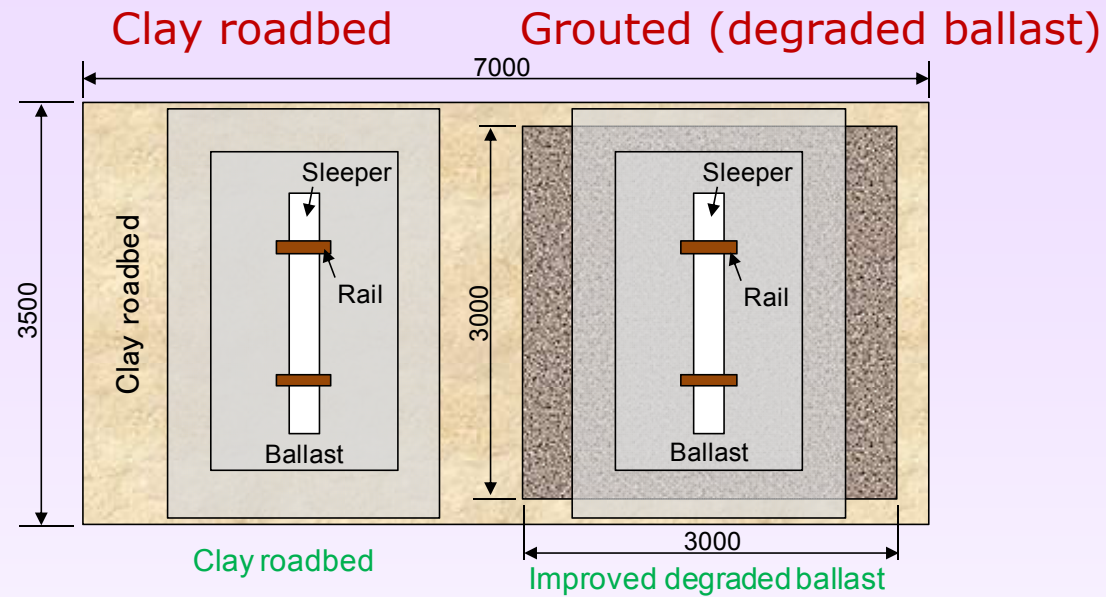
■ Test cases (Clay roadbed)

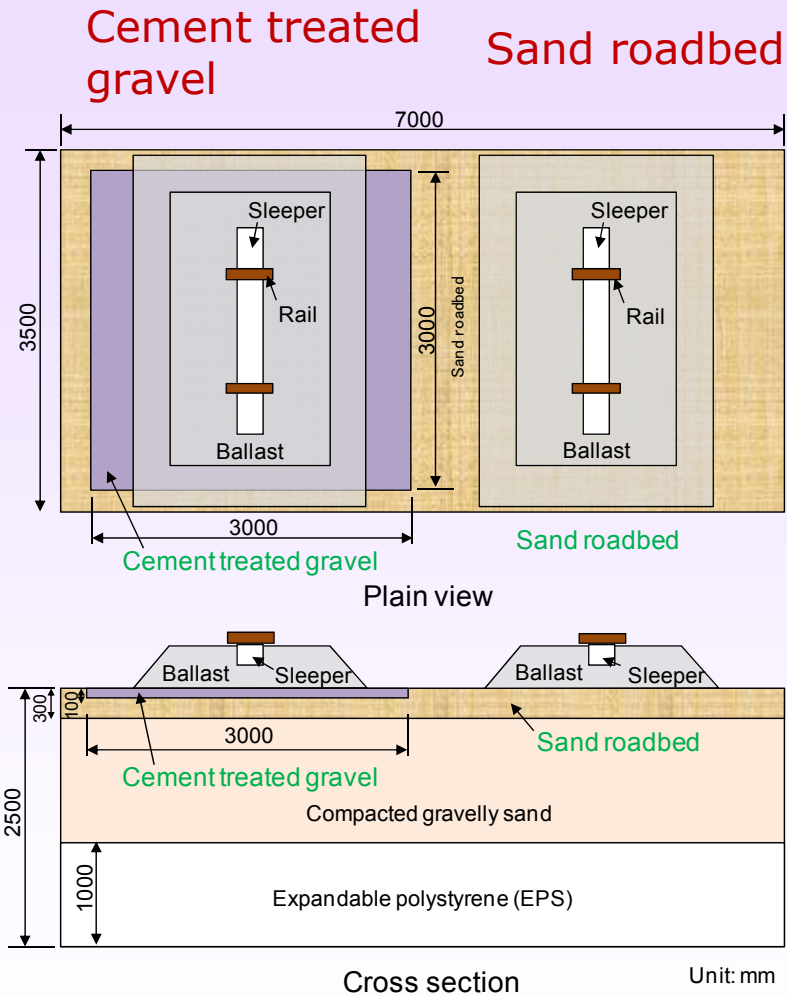
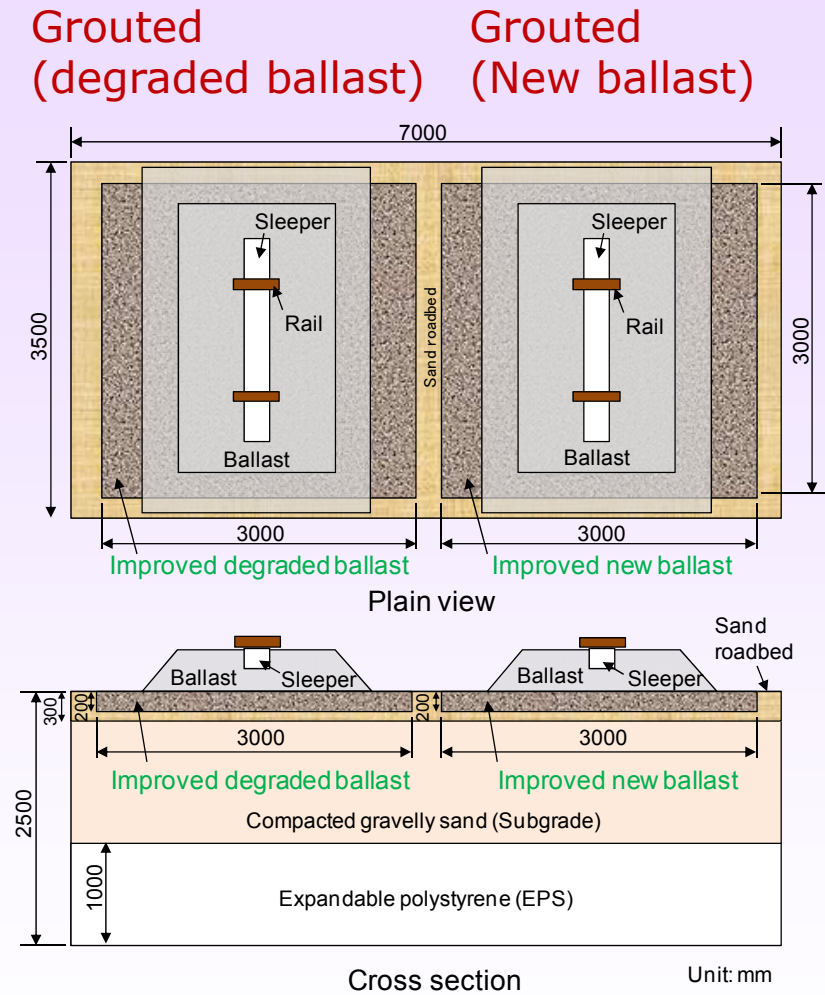
■ Test cases (Sand roadbed)

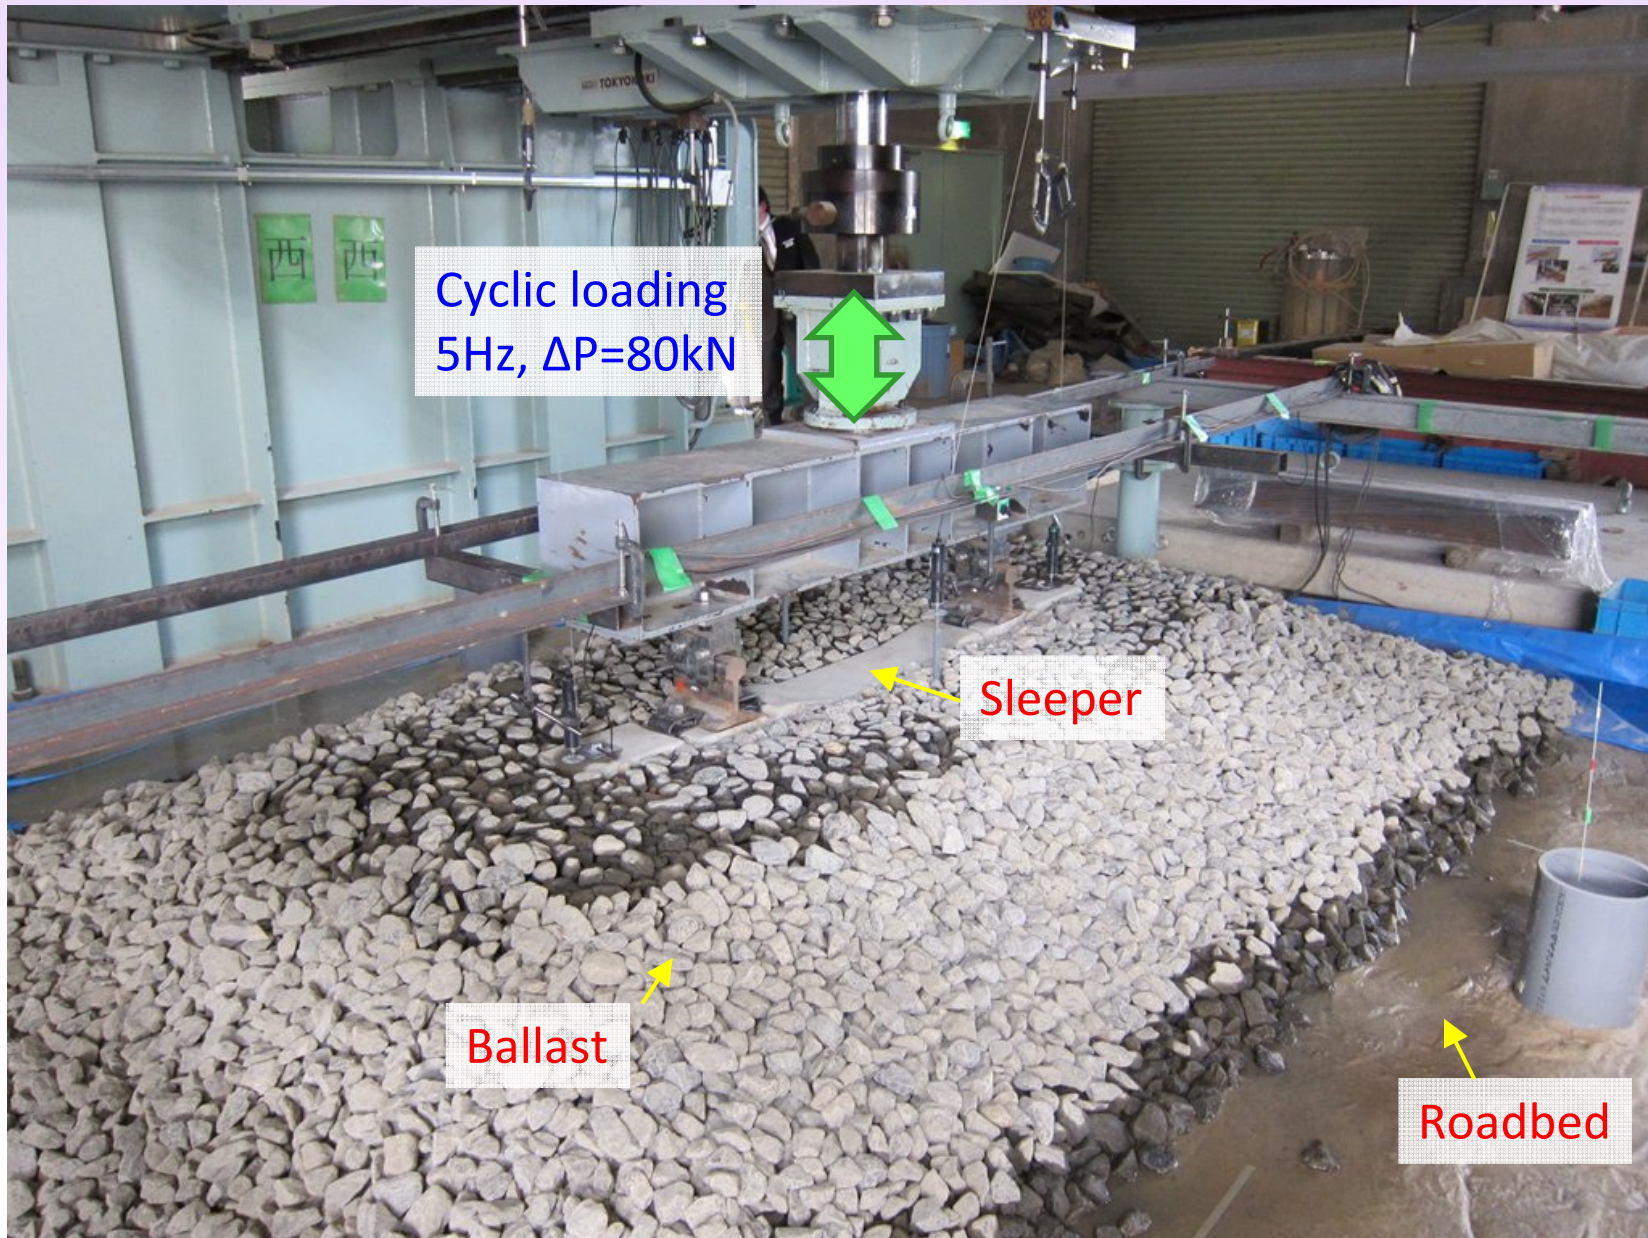
◆ Cyclic loading test

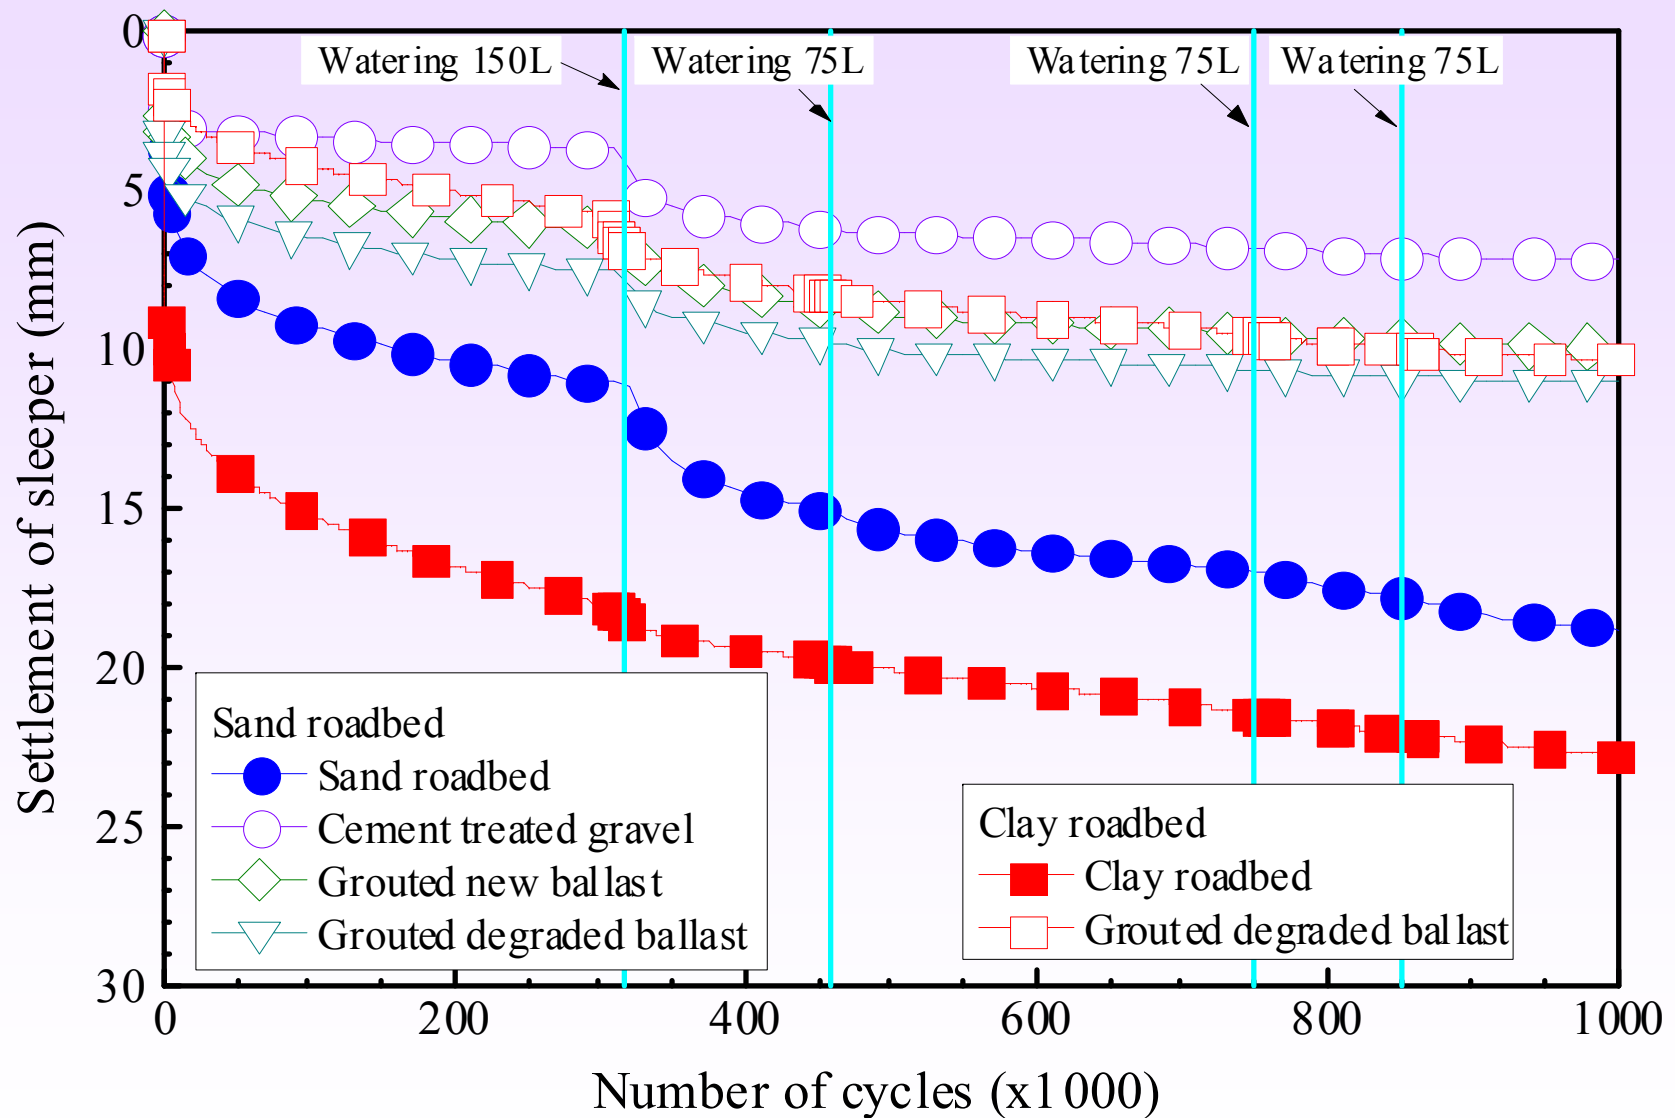
◆ Cyclic loading test results

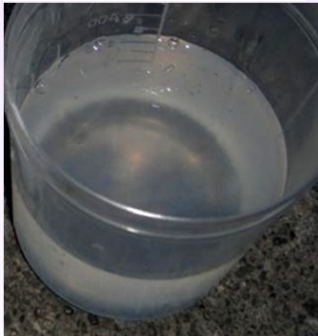
Polymer aqueous solution (PVA)

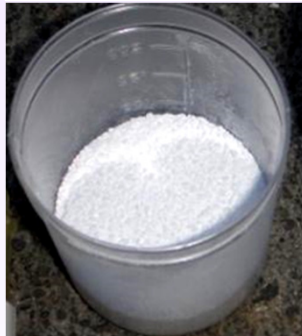
Reaction agent (Sodium silicate)

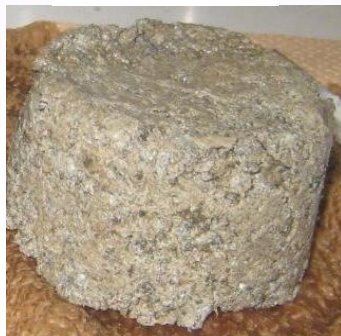
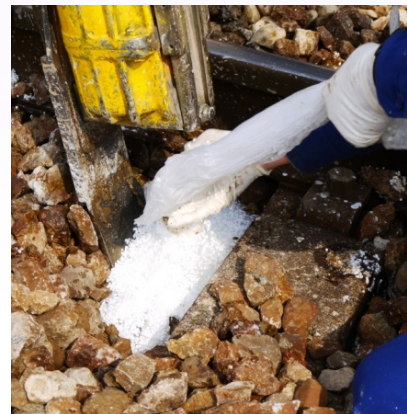
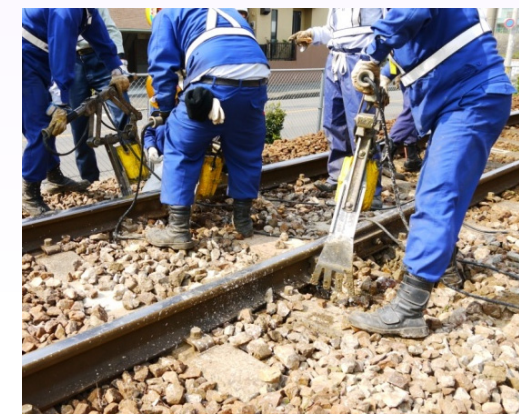
Treated soil

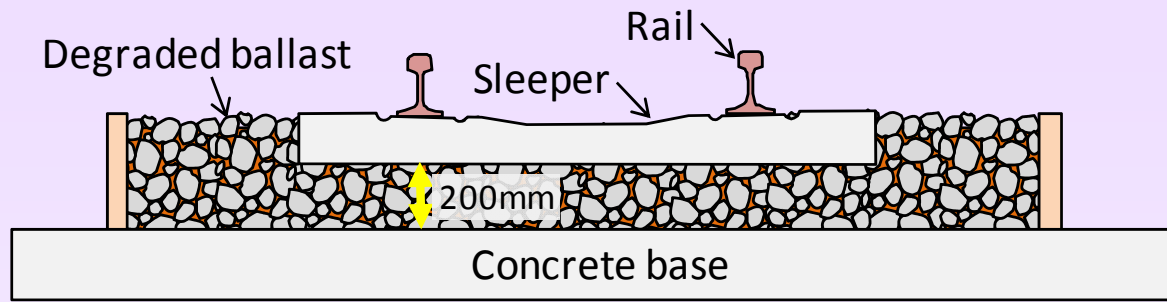
◆ Loading test condition

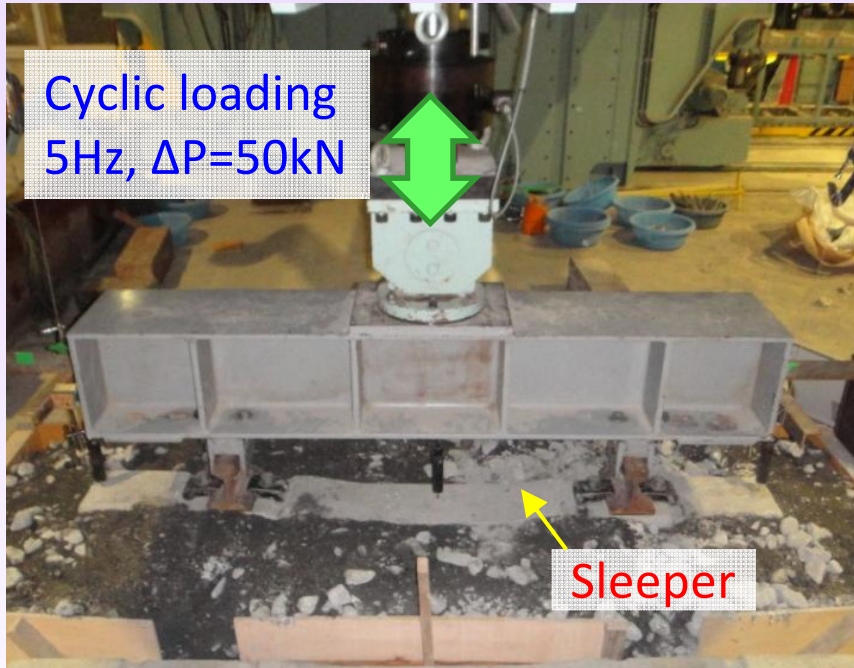
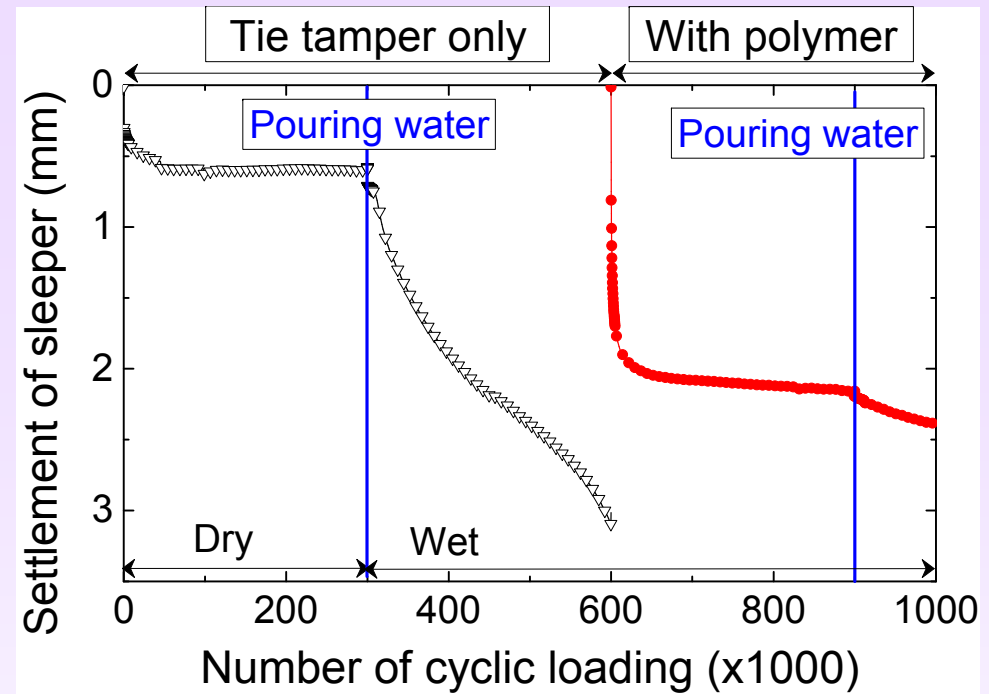
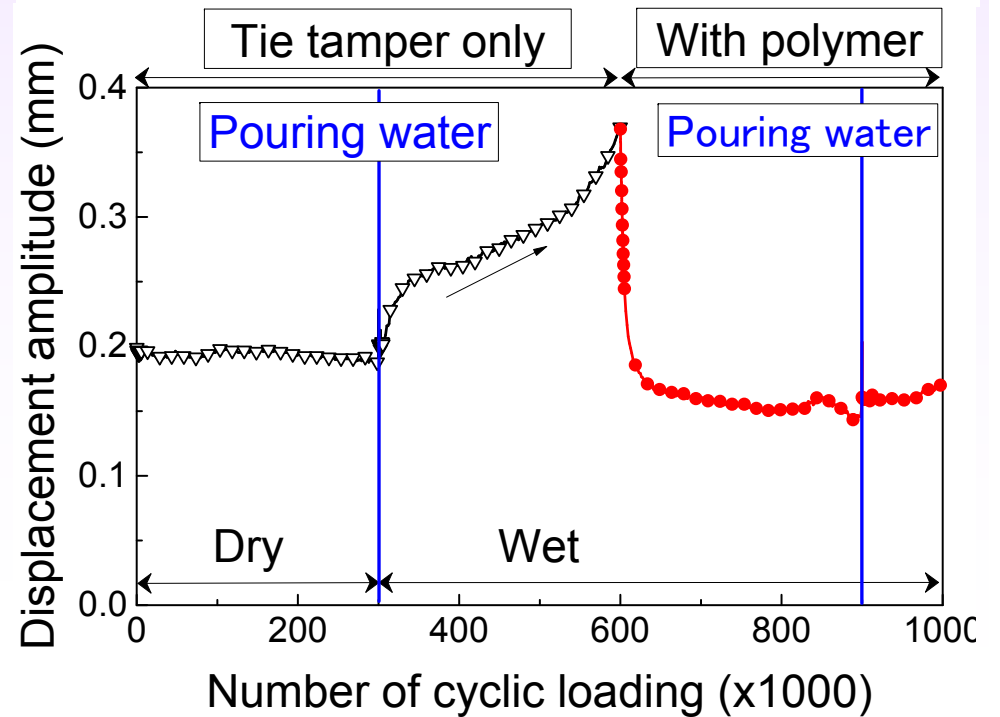
◆ Cyclic loading test
