# Research Theme: Interface Shear Behaviour of PCM- Strengthened Reinforced Concrete Beam Under Fatigue Loading

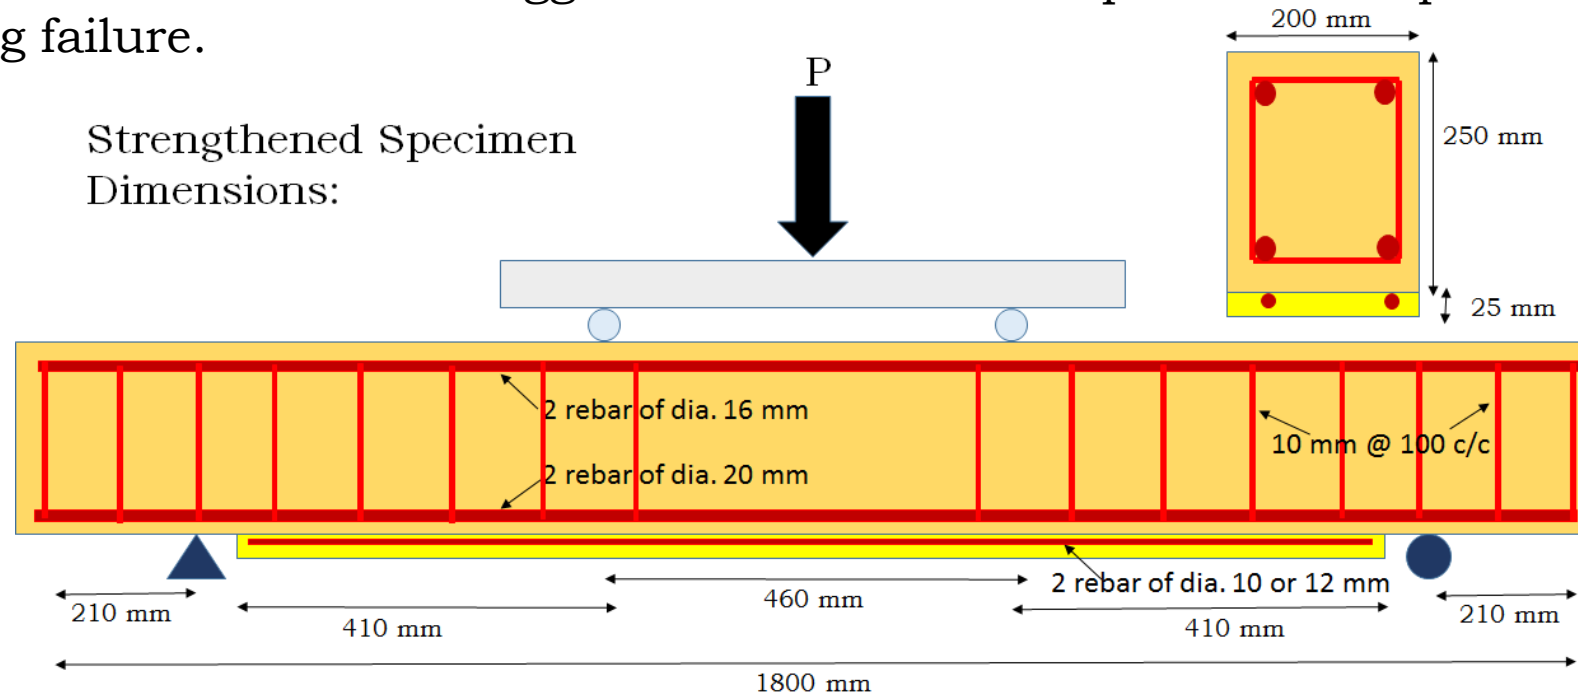
Reinforced concrete beams strengthened in flexure by spraying repair material to the tension face are susceptible to brittle debonding failures. Interface of the existing concrete and repair material is the weakest link in the structure. Polymer Cement Mortar (PCM) is known as good repair material due to its higher bond strength, lower permeability and thinner construction thickness. In fatigue loading, structures goes under cyclic loading and fails at much lower load than their yielding limit. So, this study will give a new idea about progress of development of shear stress at interface and suggest some conservative provisions to prevent the brittle debonding failure.
